# Site Management Plan Fiscal Years 2015—2016

# Naval Weapons Station Yorktown Yorktown, Virginia

Contract Task Order WE88

August 2014

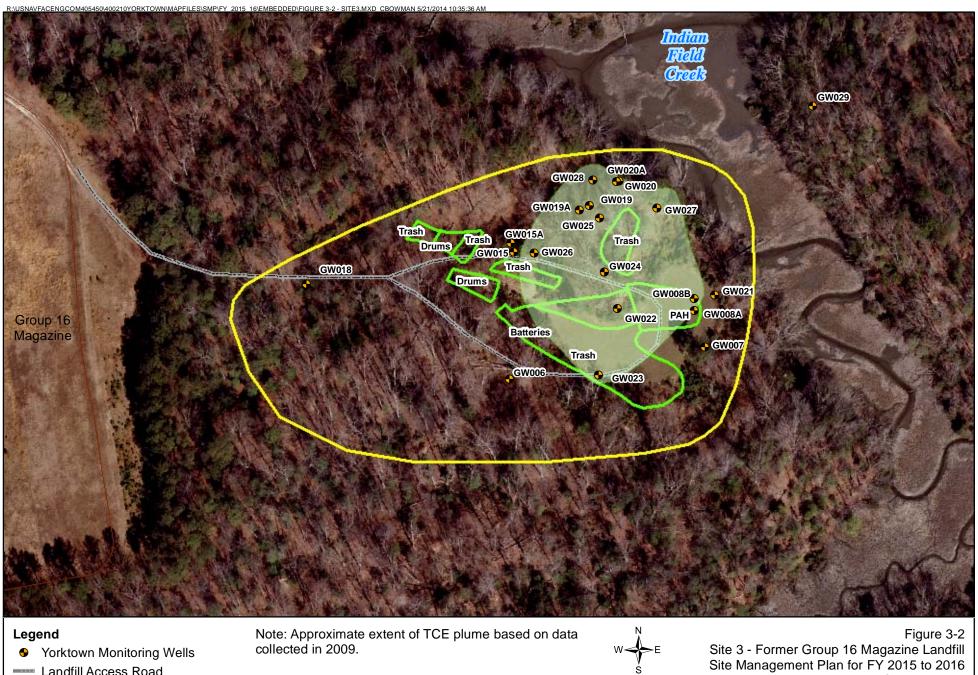
--- Landfill Access Road

Approximate Extent of TCE Plume

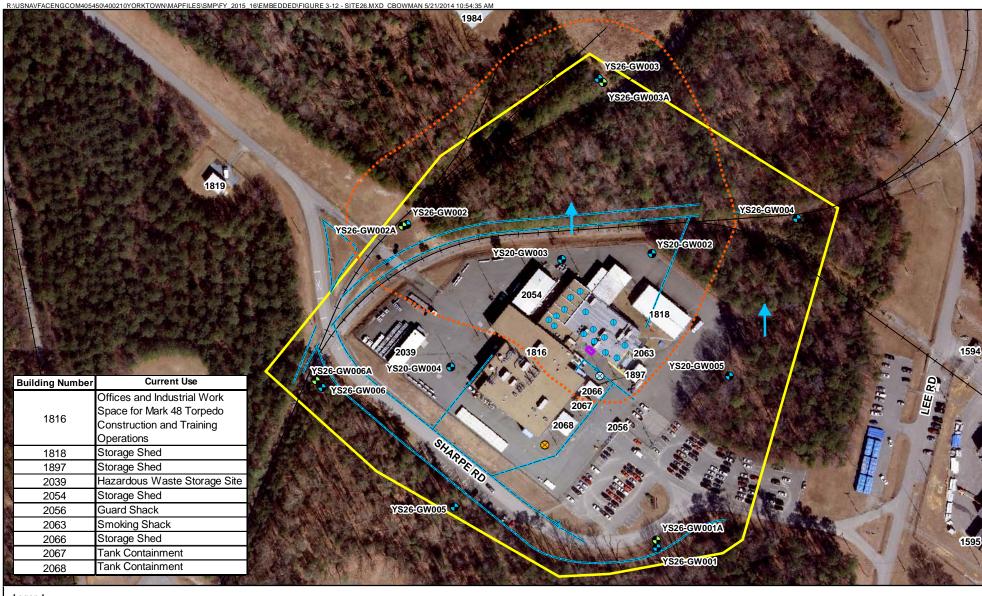
The reported dimensions of the 2,500-gallon Waste Otto Fuel Oil UST removal area were 17'x19'x8'. The bottom of the tank remains approximately 8 ft bgs.

Site 26 includes a 2,500-gallon concrete UST and network of ancillary drain pipes that were formerly used to store waste Otto fuel. The tank was installed in 1974 andin late 1987, waste Otto fuel was discovered leaking from the tank. The tank was not equipped with a secondary containment system. The waste fuel stored in the tank consisted of a liquid mixture of Otto fuel and water; it may also have contained oils, denatured ethyl alcohol, detergent, and trace amounts of cyanide, halogenated hydrocarbons, and heavy metals such as arsenic, barium, cadmium, chromium, lead, mercury, selenium, and silver. The fuel was removed, the tank was cleaned, and a RCRA closure permit was filed. During the removal action, some contaminated soil was noted and removed. However, before the tank removal was completed, the excavation sides collapsed and the base of the tank was left in place. In March 1995, the waste Otto fuel UST was removed from the site. A separate, neighboring 8,000-gallon fuel oil UST was also removed from the site in 1995 and a 12,000-gallon #2 heating oil UST located in the southern portion of the site was removed in 1998. Site 26 has been retained as an ERP site because of chlorinated VOCs detected in shallow groundwater. Depth to groundwater in this area is generally 30 feet to the shallow Cornwallis Cave aquifer. The Yorktown confining unit is approximately 25 feet thick at Site 26 and separates the Cornwallis Cave aquifer from the underlying Yorktown Eastover aquifer. The topography at the site is generally flat at approximately 70 feet amsl. A summary of relevant documents and action milestones is presented in Table 3-24.
